LYNG CHURCH

Fredericia, Danemark

Roof: 2 000 m² 15 t Double Standing Seam
RHEINZINK-prePATINA blue-grey

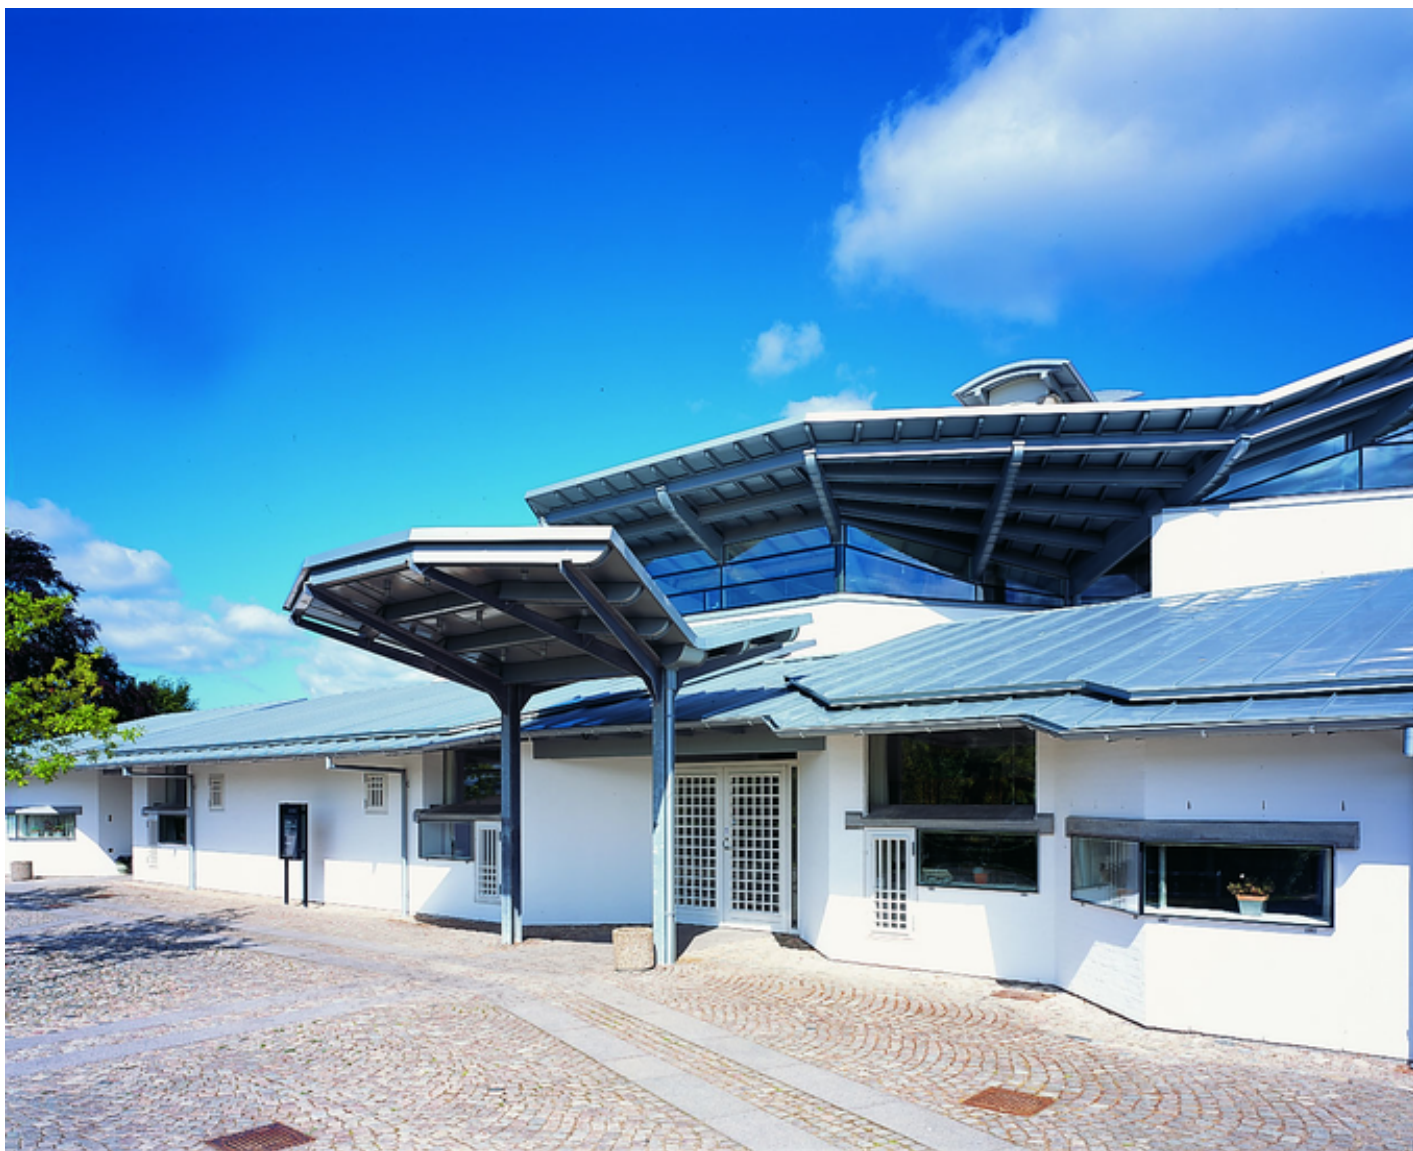
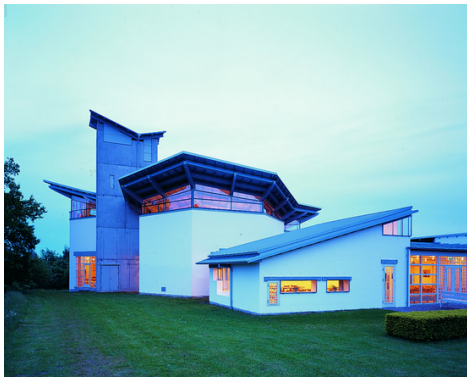
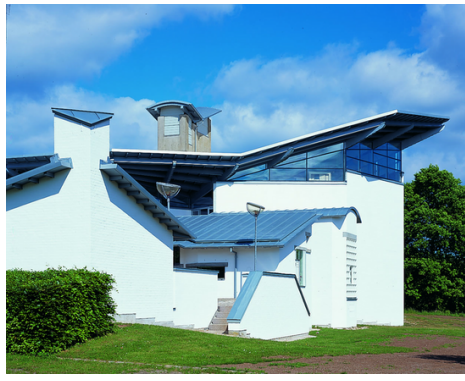
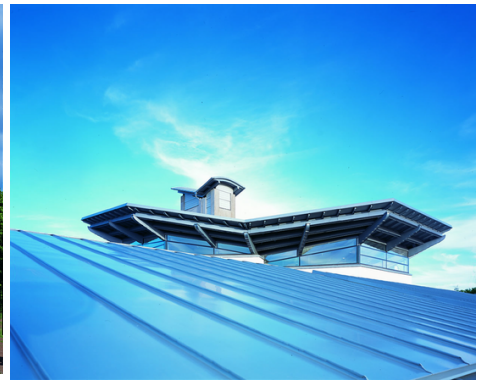
Some years ago, the roof of Lyng Church in the south of Denmark had to be restored. At that time the roofing - made of stainless steel, with defects in the joints and a very weather-exposed eaves construction with large glulam beams - took in water. As a result, the load-bearing structures in wood began to rot.

A new zinc cladding in the surface RHEINZINK prePATINA was mounted everywhere at an underlayer of 15 mm high, perforated zinc hat profiles due to extensive rot damage in roof ridges and roof edges. All rotten wood was replaced and painted before the zinc cladding was mounted. By mounting the perforated profiles, an 18 mm. ventilated cavity was ensured between the zinc cladding and the existing wooden structures.

To achieve an optimal airflow, the cladding on the back of all main girders, roof trusses and rafters is made of perforated zinc. The zinc overhang cladding is made with an air gap at all edges - also in perforated zinc. Perforation with a hole diameter of 3 mm. was chosen, as this hole size ensures that bees and other insects are not able to enter the ventilated cavities.
